Reserve Study

Villa Del Mar of Clearwater COA

1860 N Fort Harrison Ave, Clearwater, Florida 33755

February 2, 2024

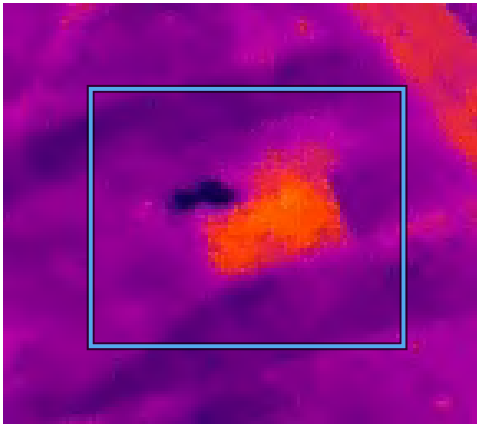
Title: Water Damage

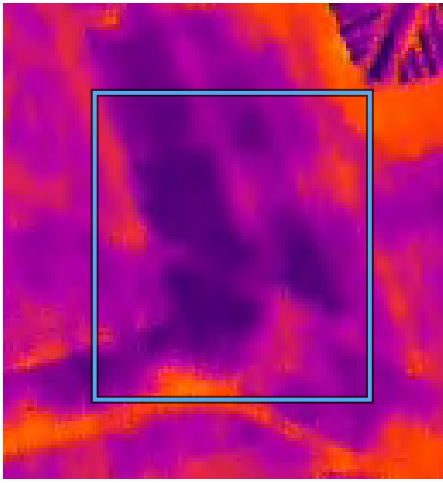
A7

Title: Water Damage

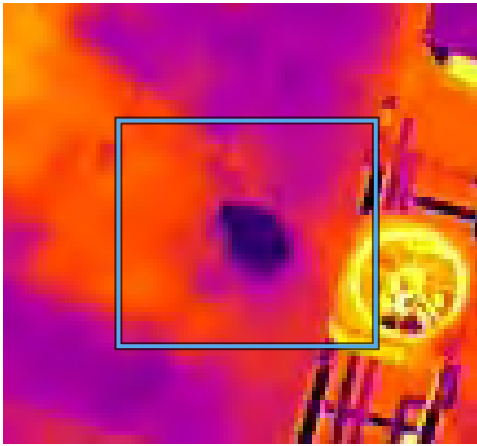
A9

Title: Water Damage

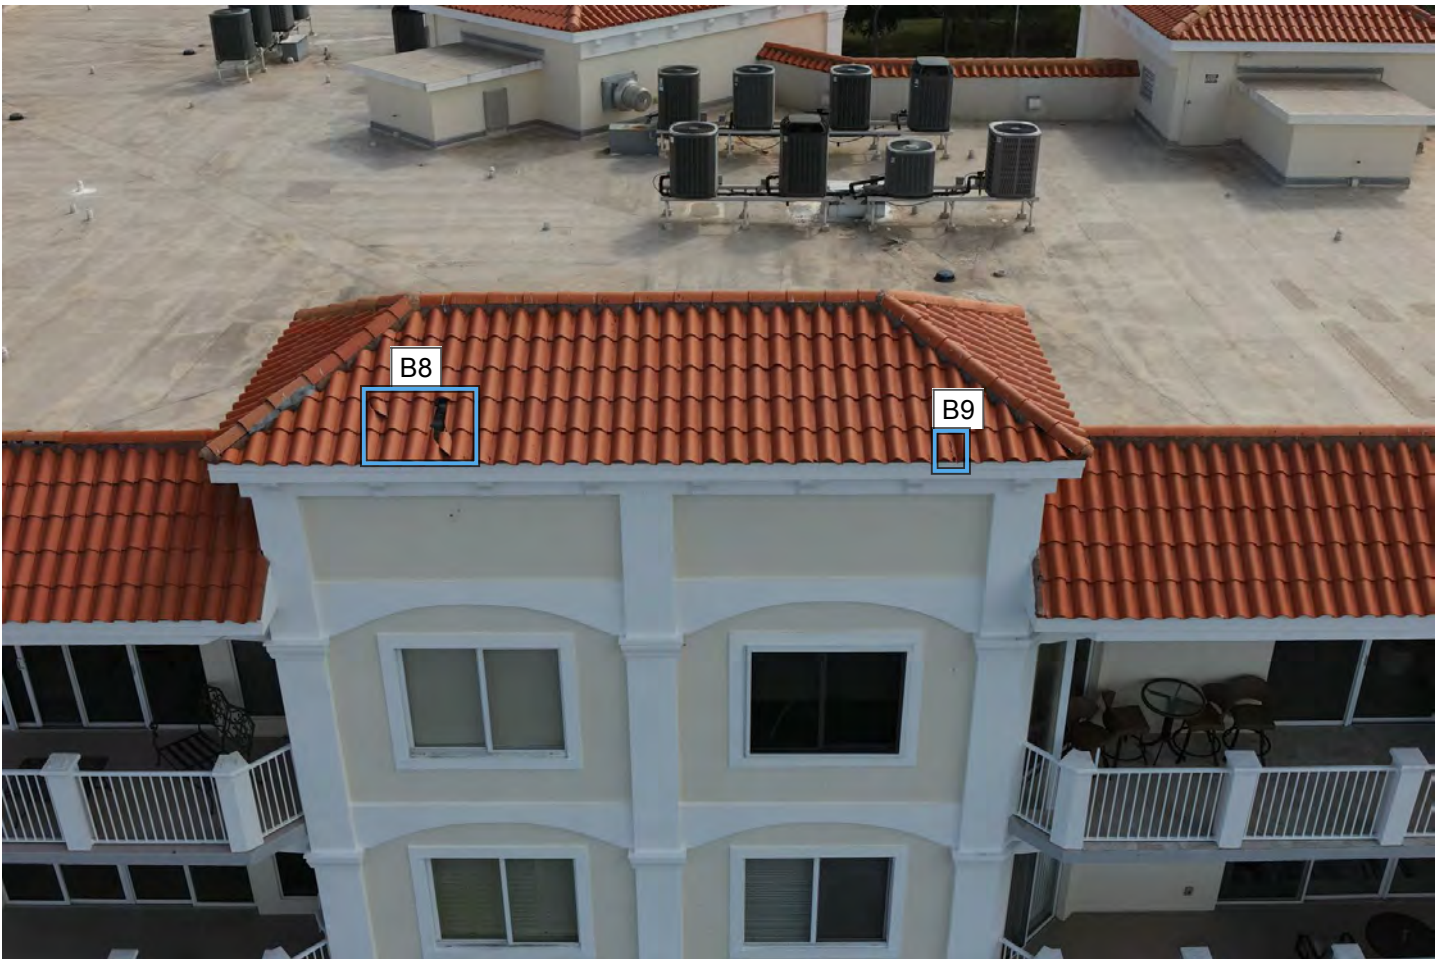
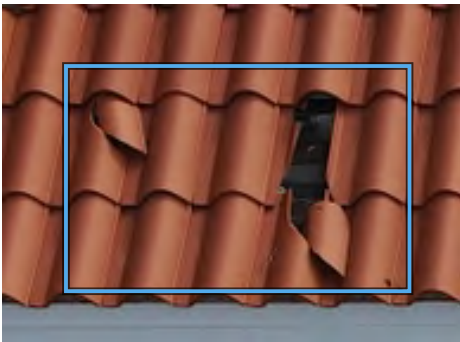
BF

Title: Broken Tile

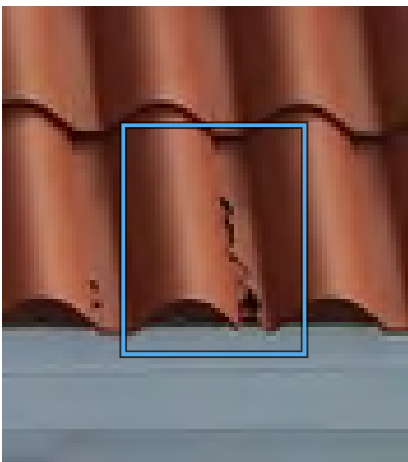
B8

Title: Broken Tiles

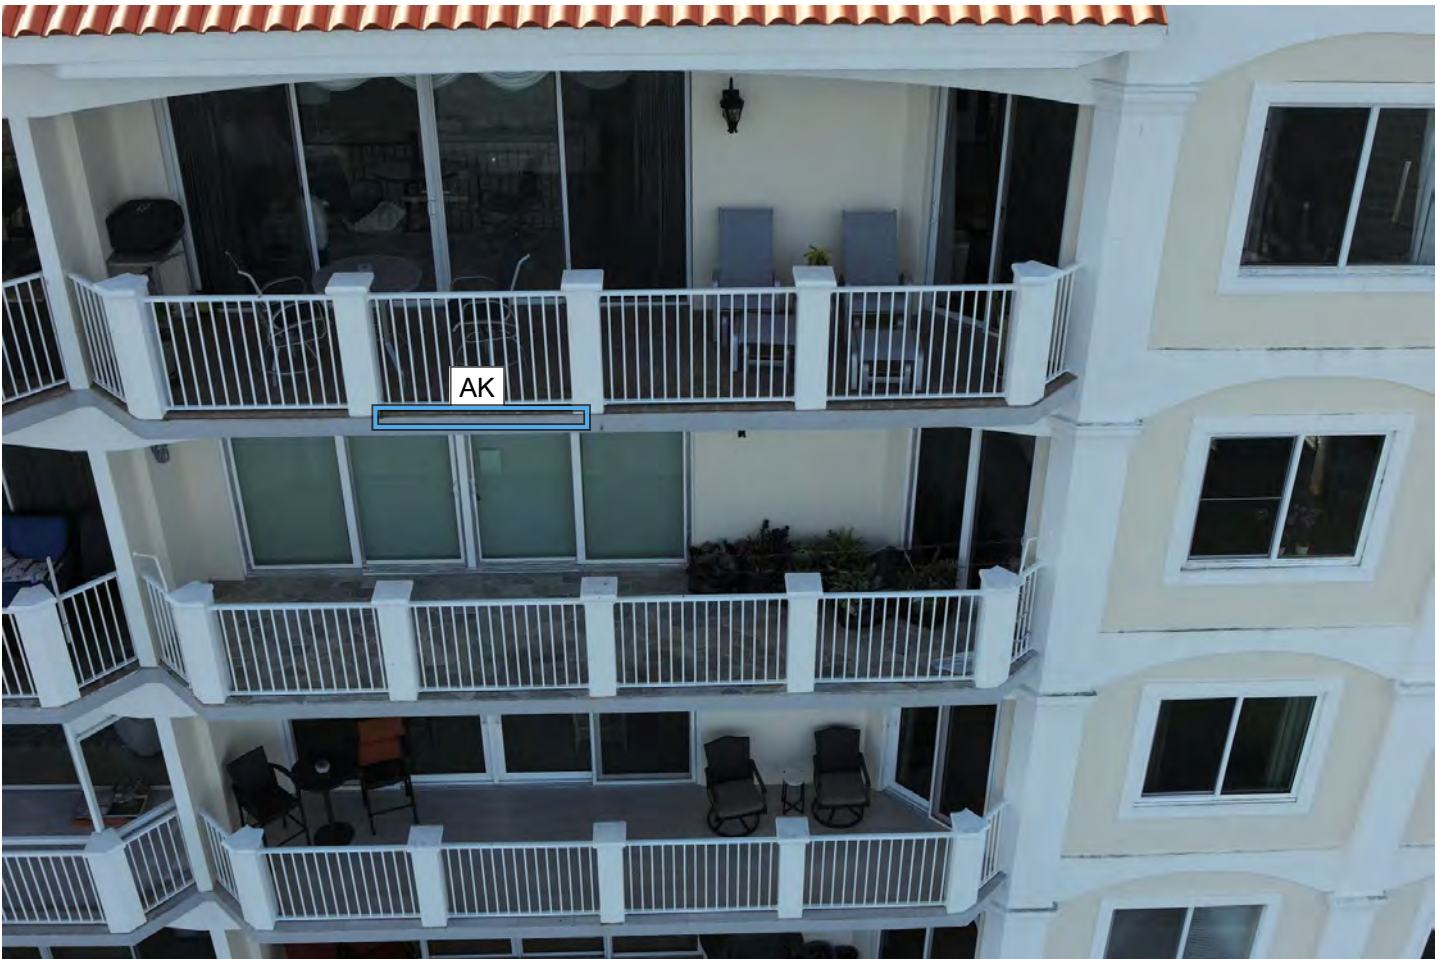
Title: Hole in the Concrete

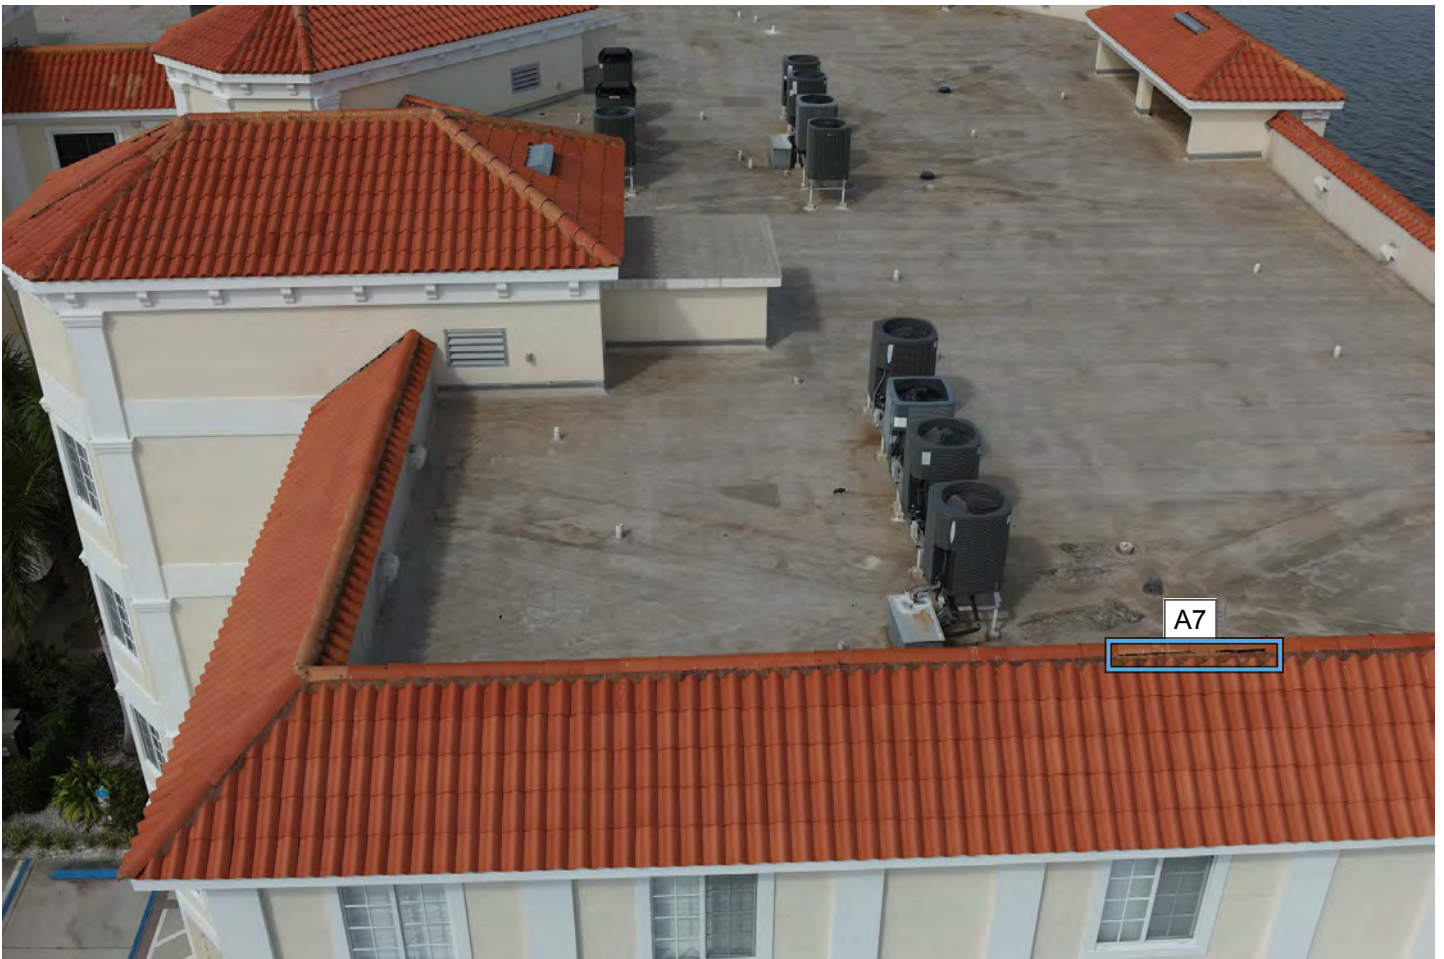
Title: Missing Cover Piece
