Reserve Study

Villa Del Mar of Clearwater COA

1860 N Fort Harrison Ave, Clearwater, Florida 33755

February 2, 2024

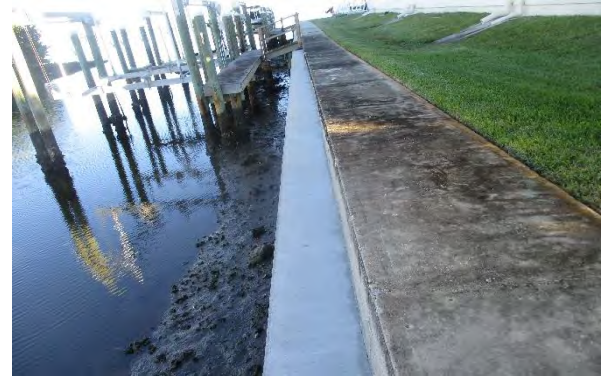
6 Retaining Wall Overview

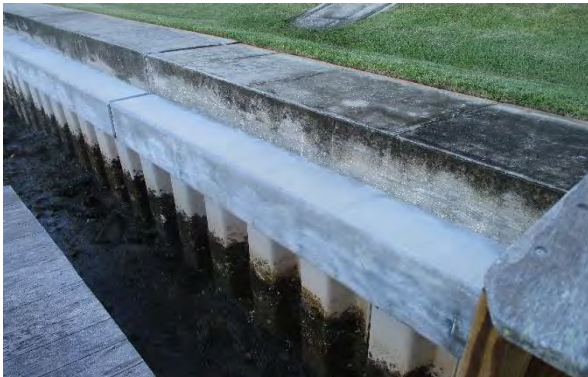
7 Retaining Wall Overview

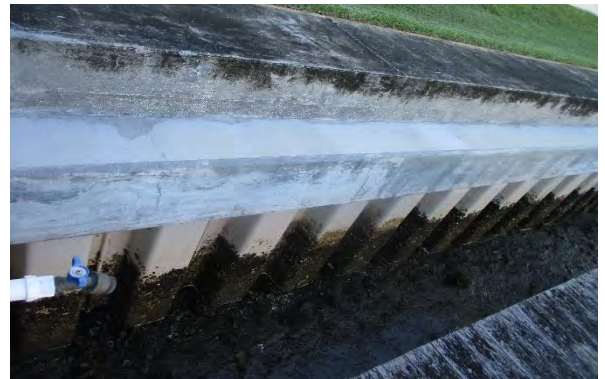
8 Retaining Wall Overview

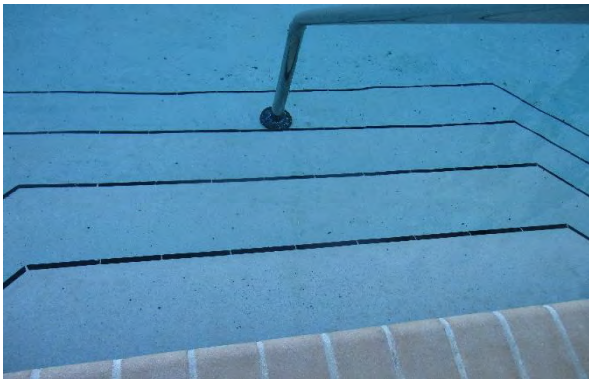
21 Pool Surface Overview

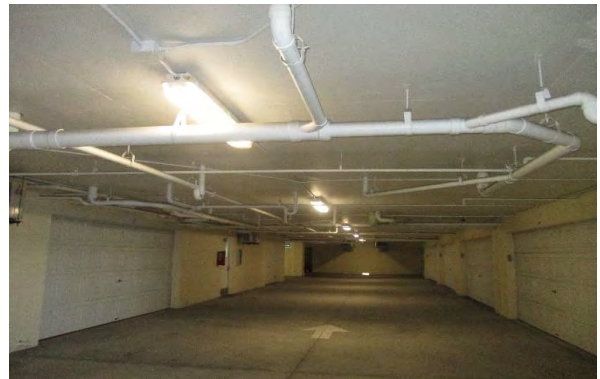
24 Plumbing Chase Overview

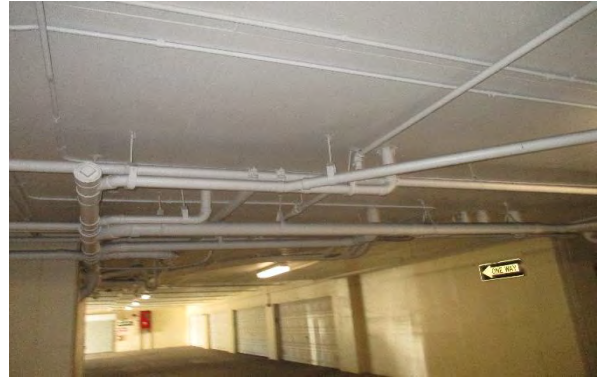
26 Plumbing Chase Overview

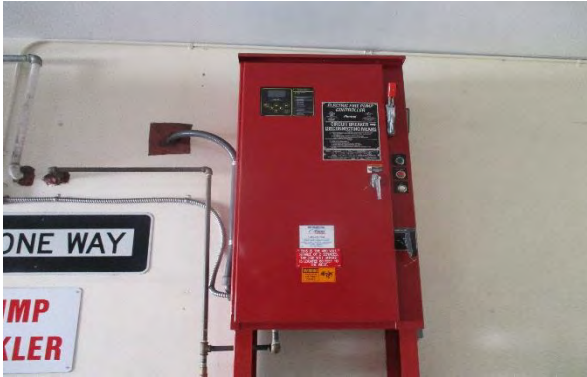
27 Fire Alarm Overview

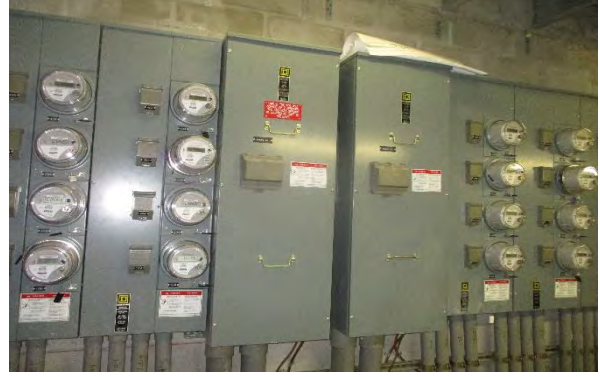
28 Breaker Panel Overview

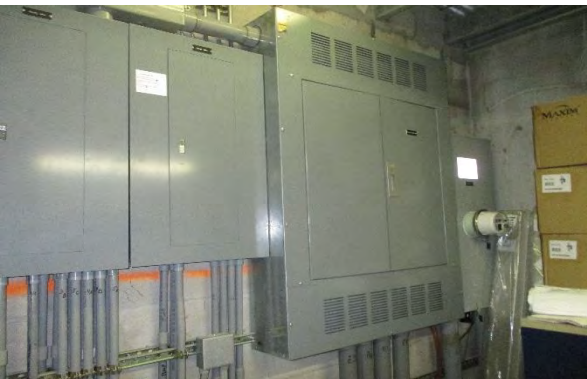
29 Breaker Panel Overview

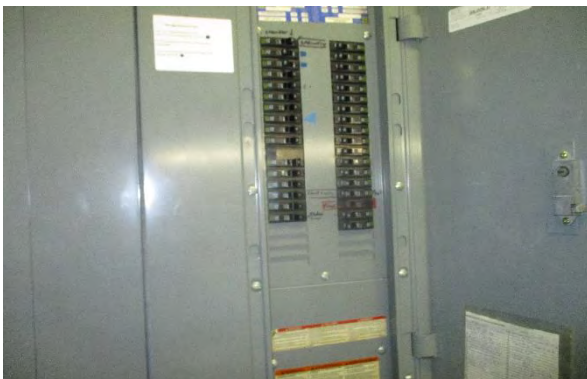
31 Breaker Panel Overview

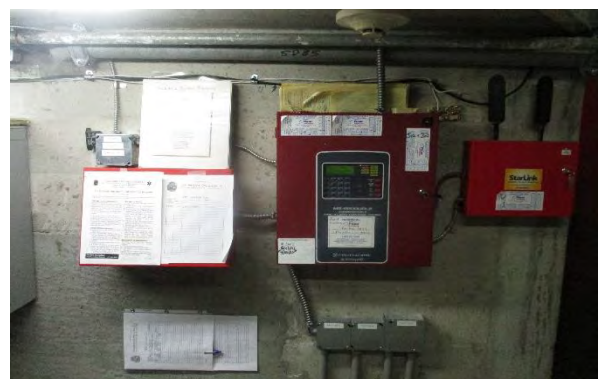
32 Security Alarm Overview
