Reserve Study

Villa Del Mar of Clearwater COA

1860 N Fort Harrison Ave, Clearwater, Florida 33755

February 2, 2024

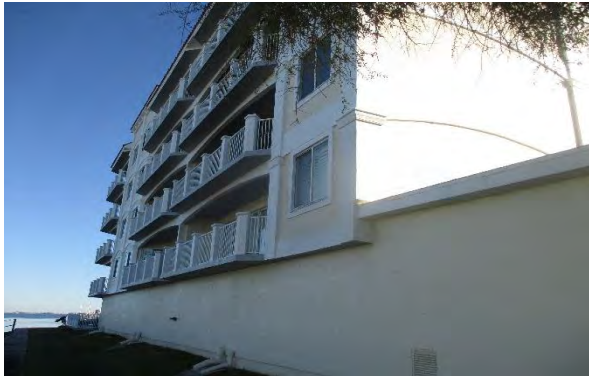
5 Exterior Overview

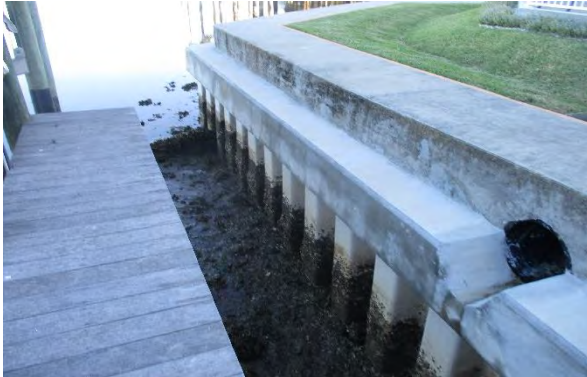
11 Retaining Wall Overview

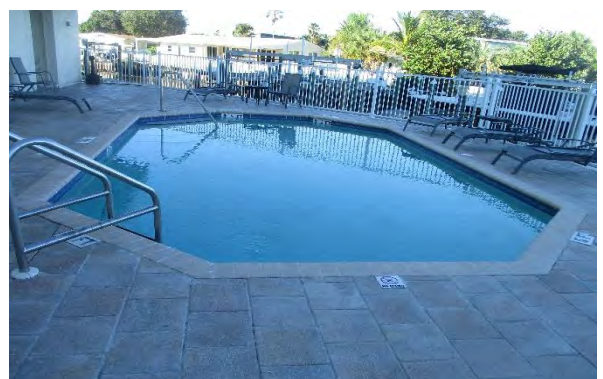
16 Pool Overview

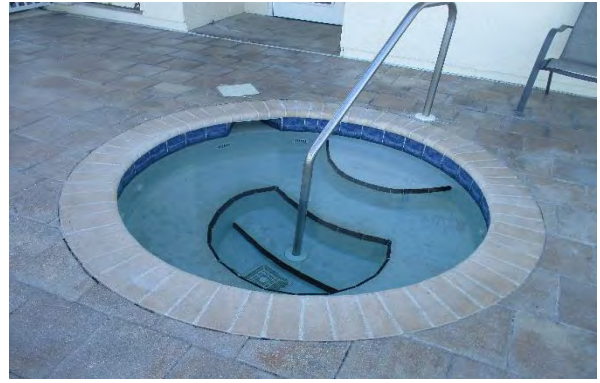
18 Spa Overview

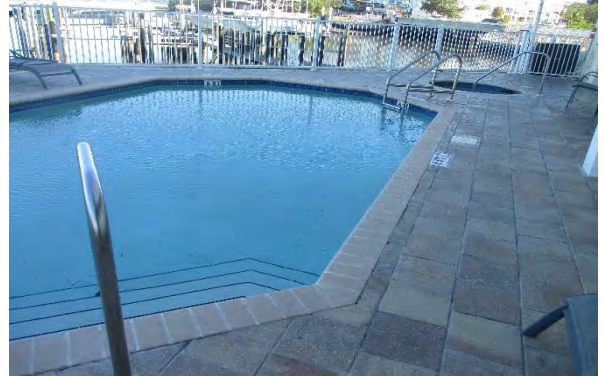
20 Pool Deck Overview

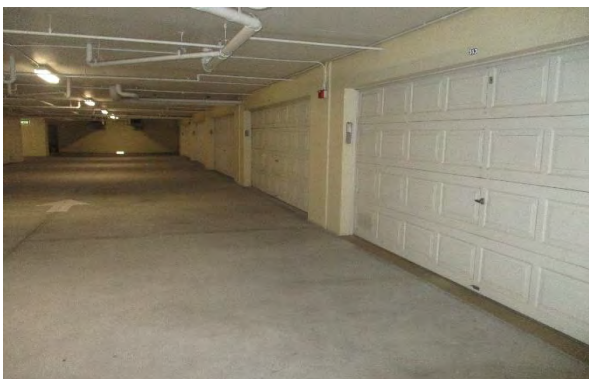
23 Inside Garage Overview

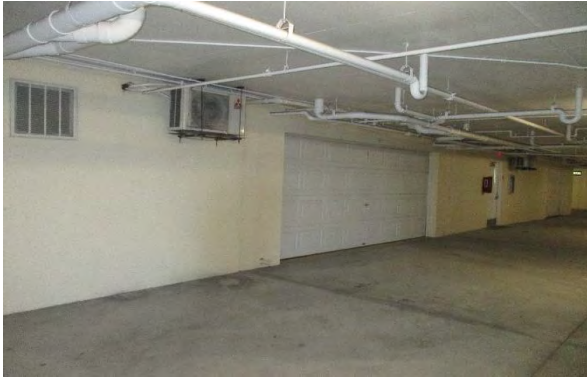
25 Inside Garage Overview

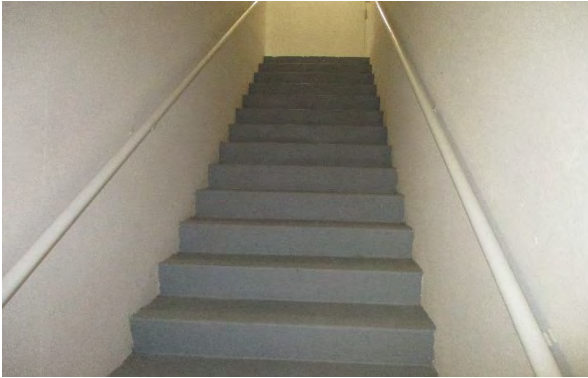
33 Stairway Overview

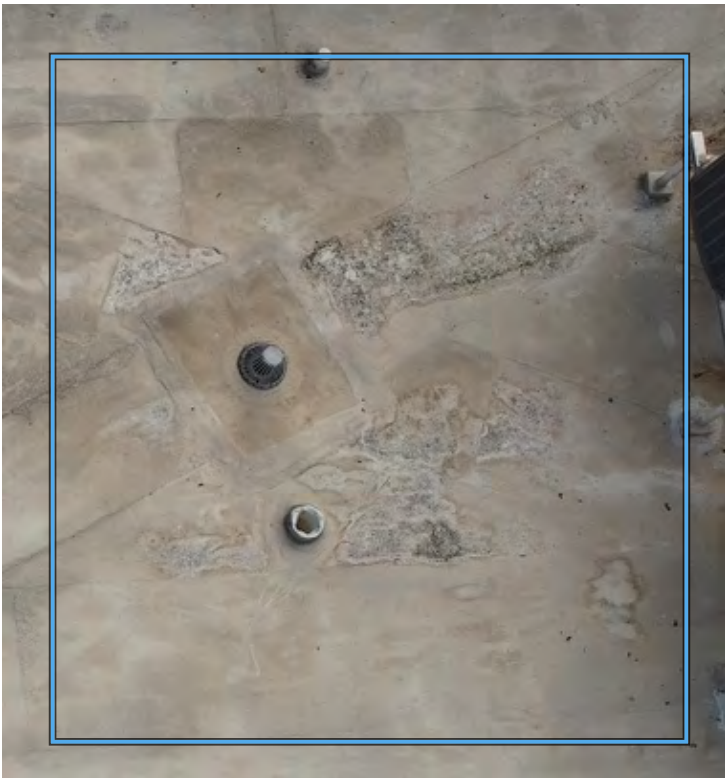
BT

Title: Water Pooling

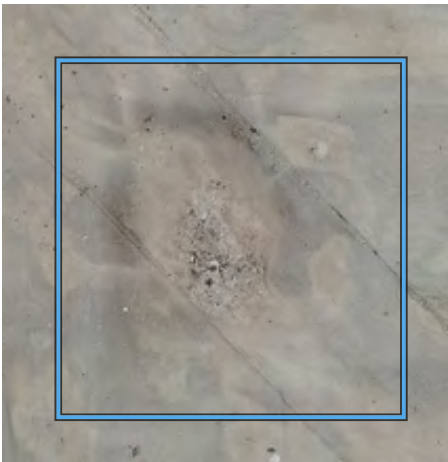
BM

Title: Water Pooling

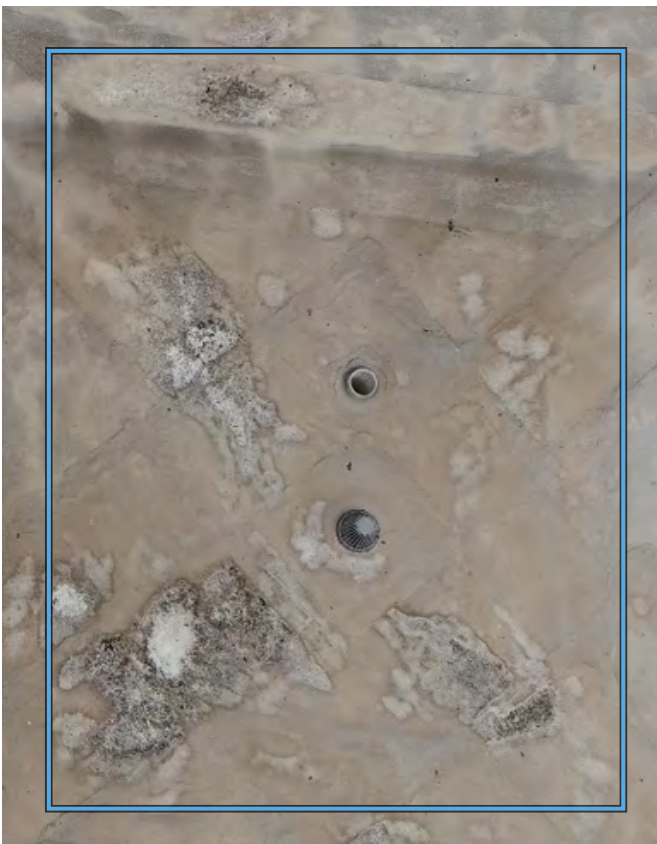
BL

Title: Water Pooling

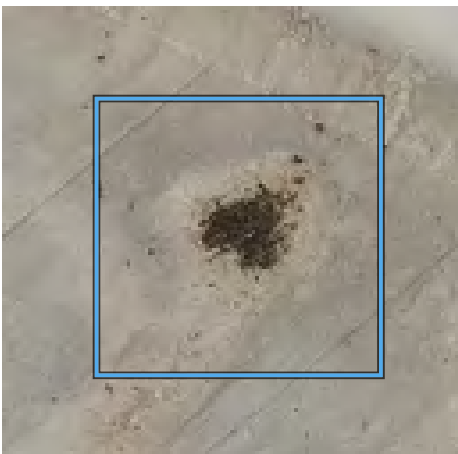
BH

Title: Water Pooling

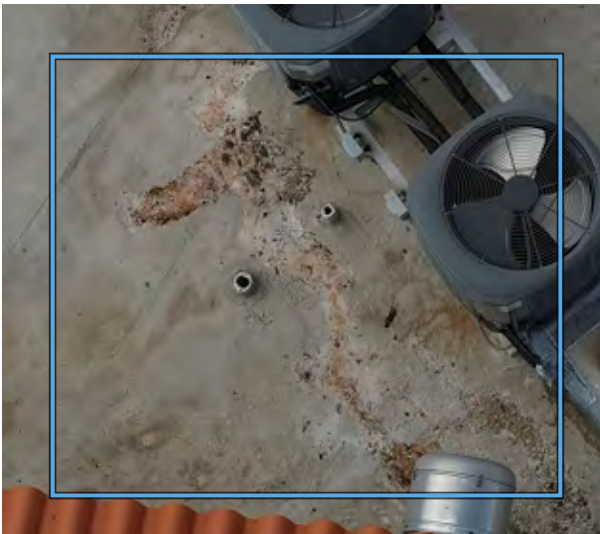
BK

Title: Water Pooling

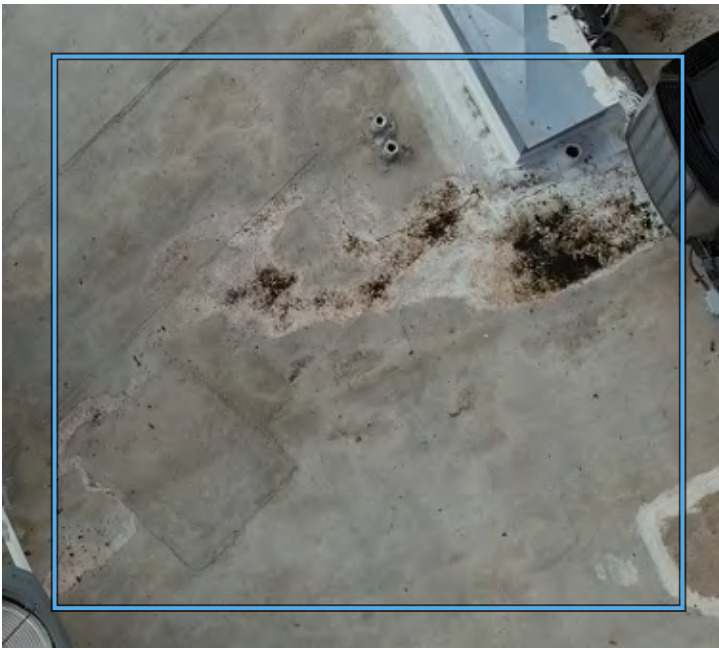
BI

Title: Water Pooling

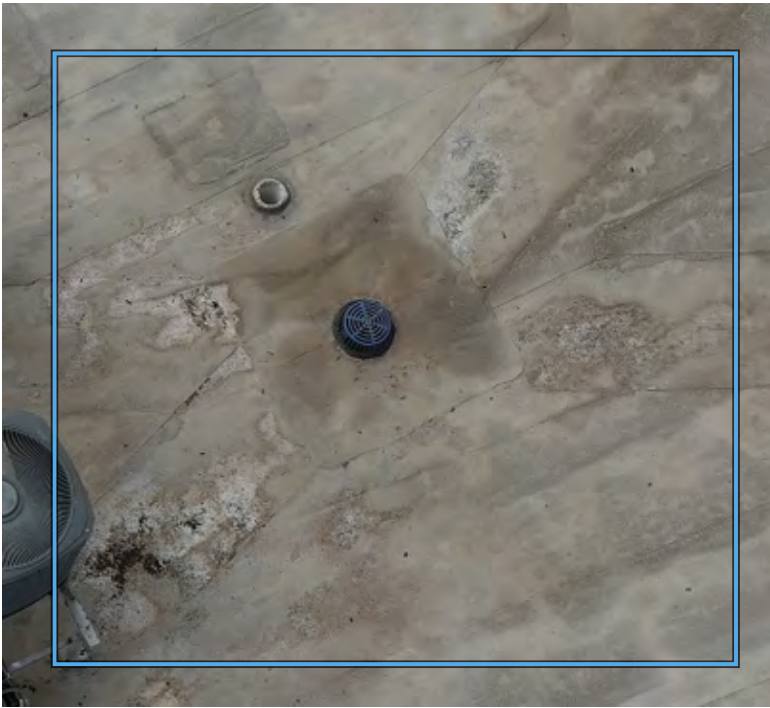
BJ

Title: Water Pooling

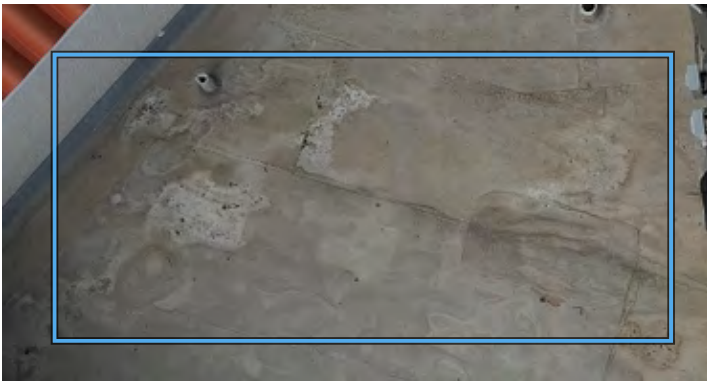
BP

Title: Water Pooling

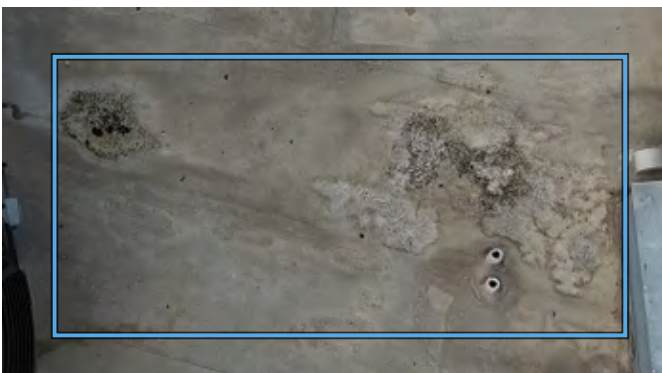
BQ

Title: Water Pooling

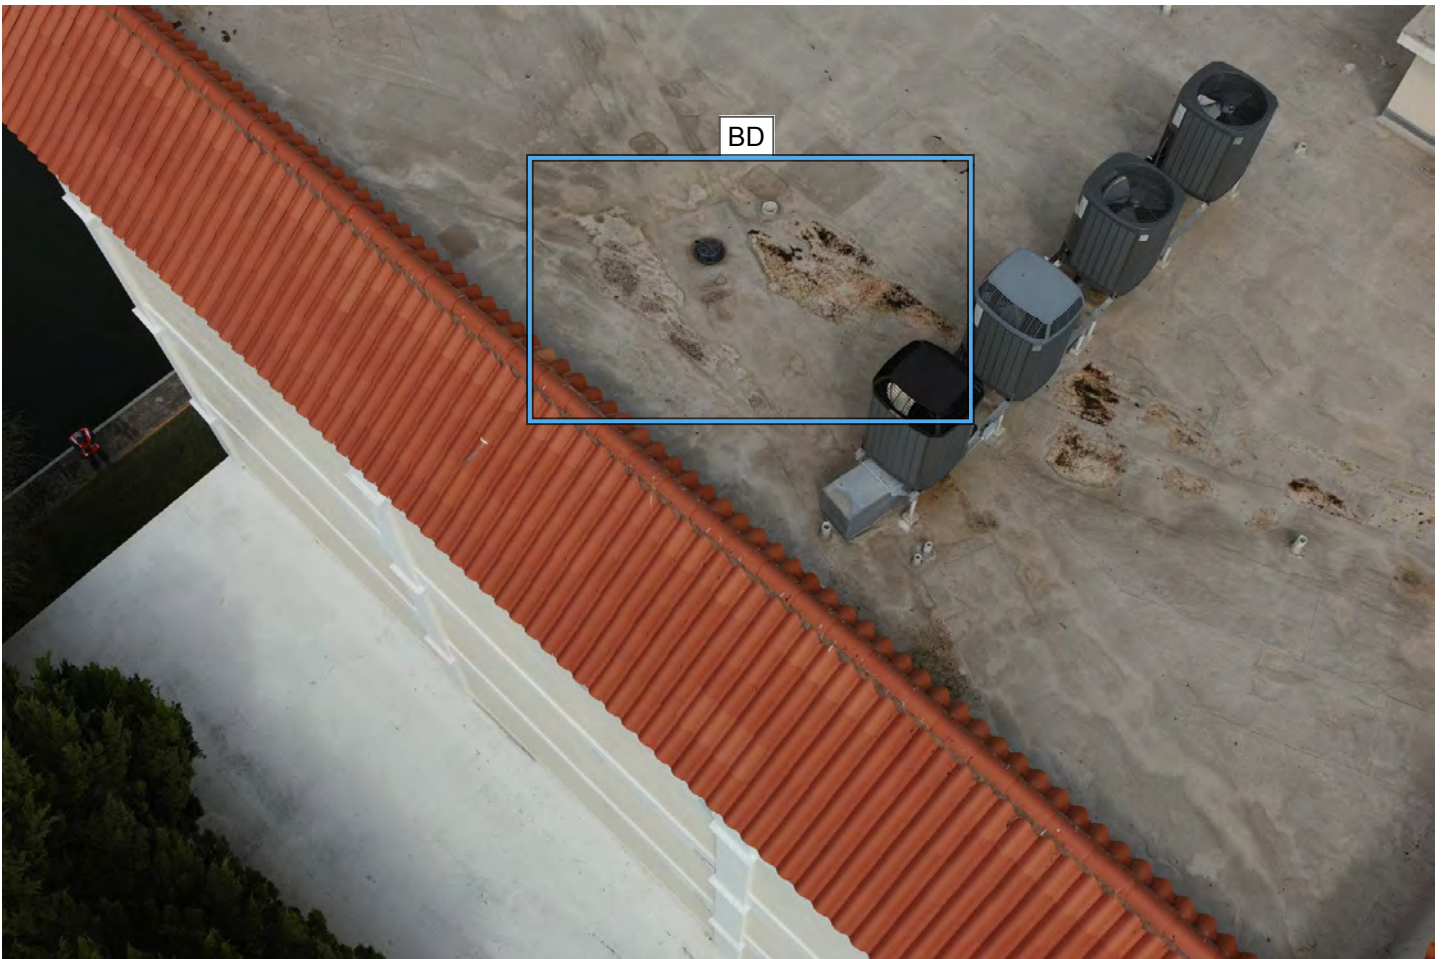
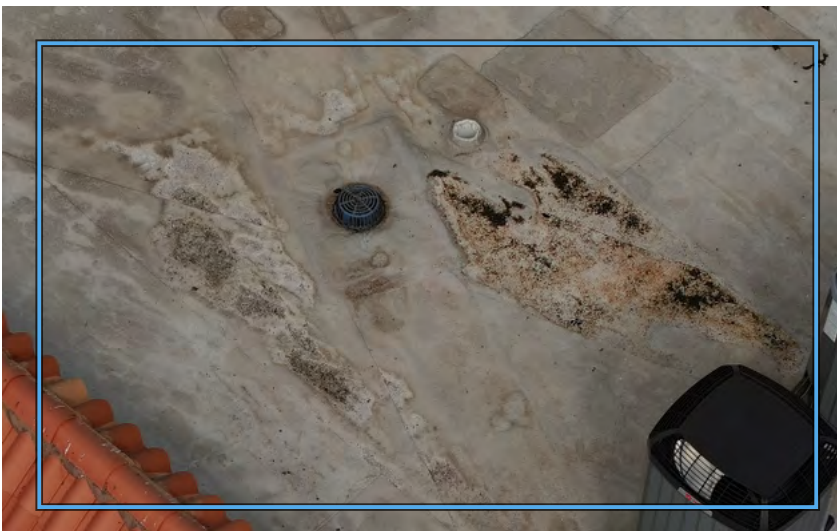
BD

Title: Water Pooling

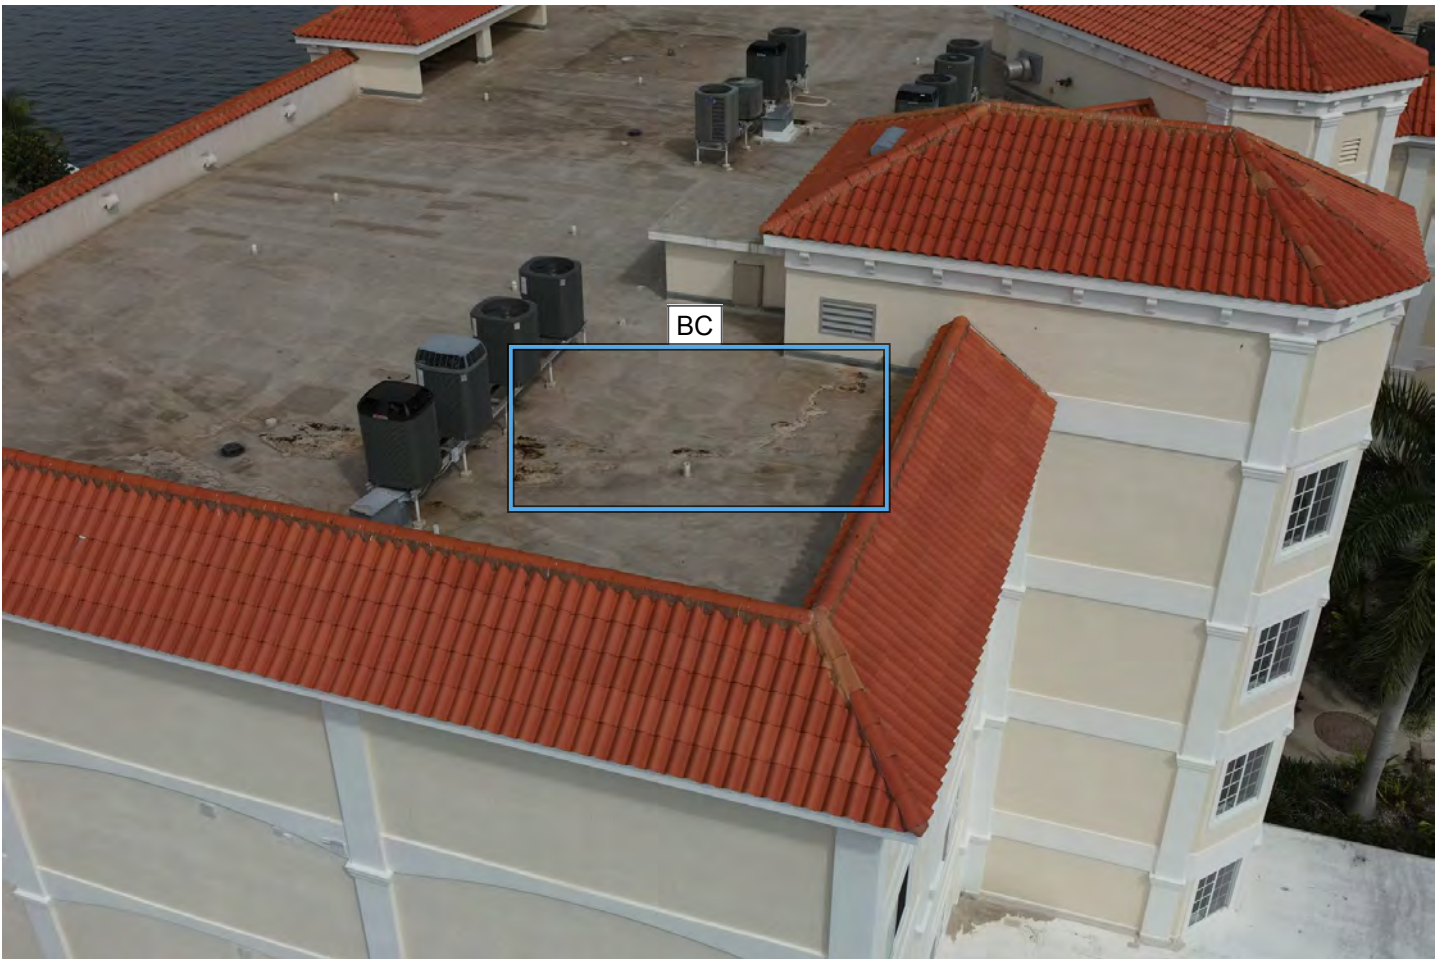
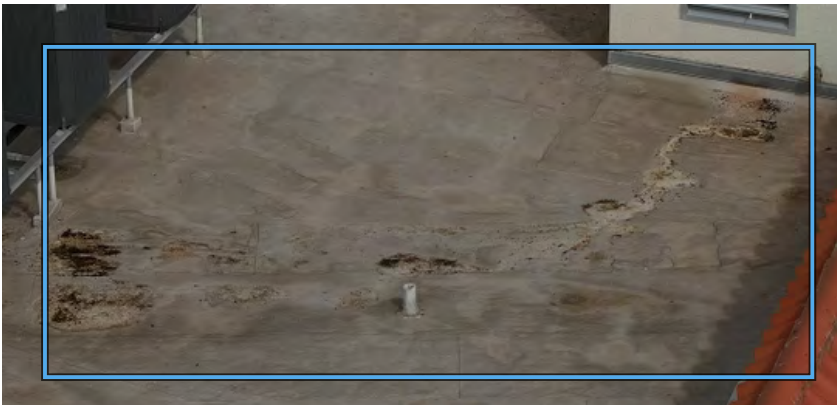
BC

Title: Water Pooling

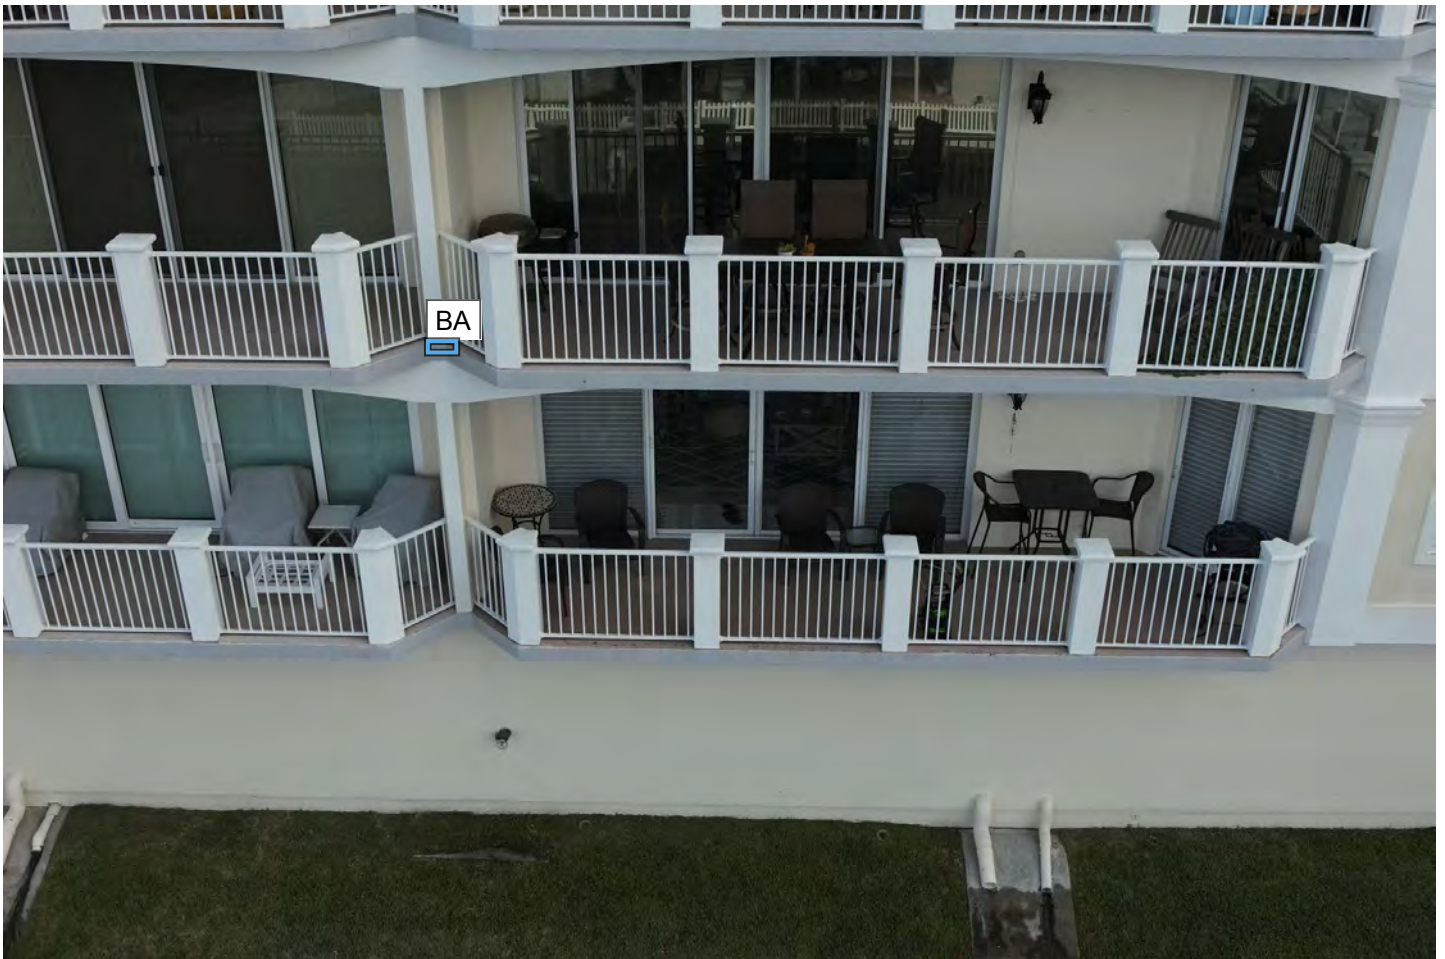
BA

Title: Water Pooling

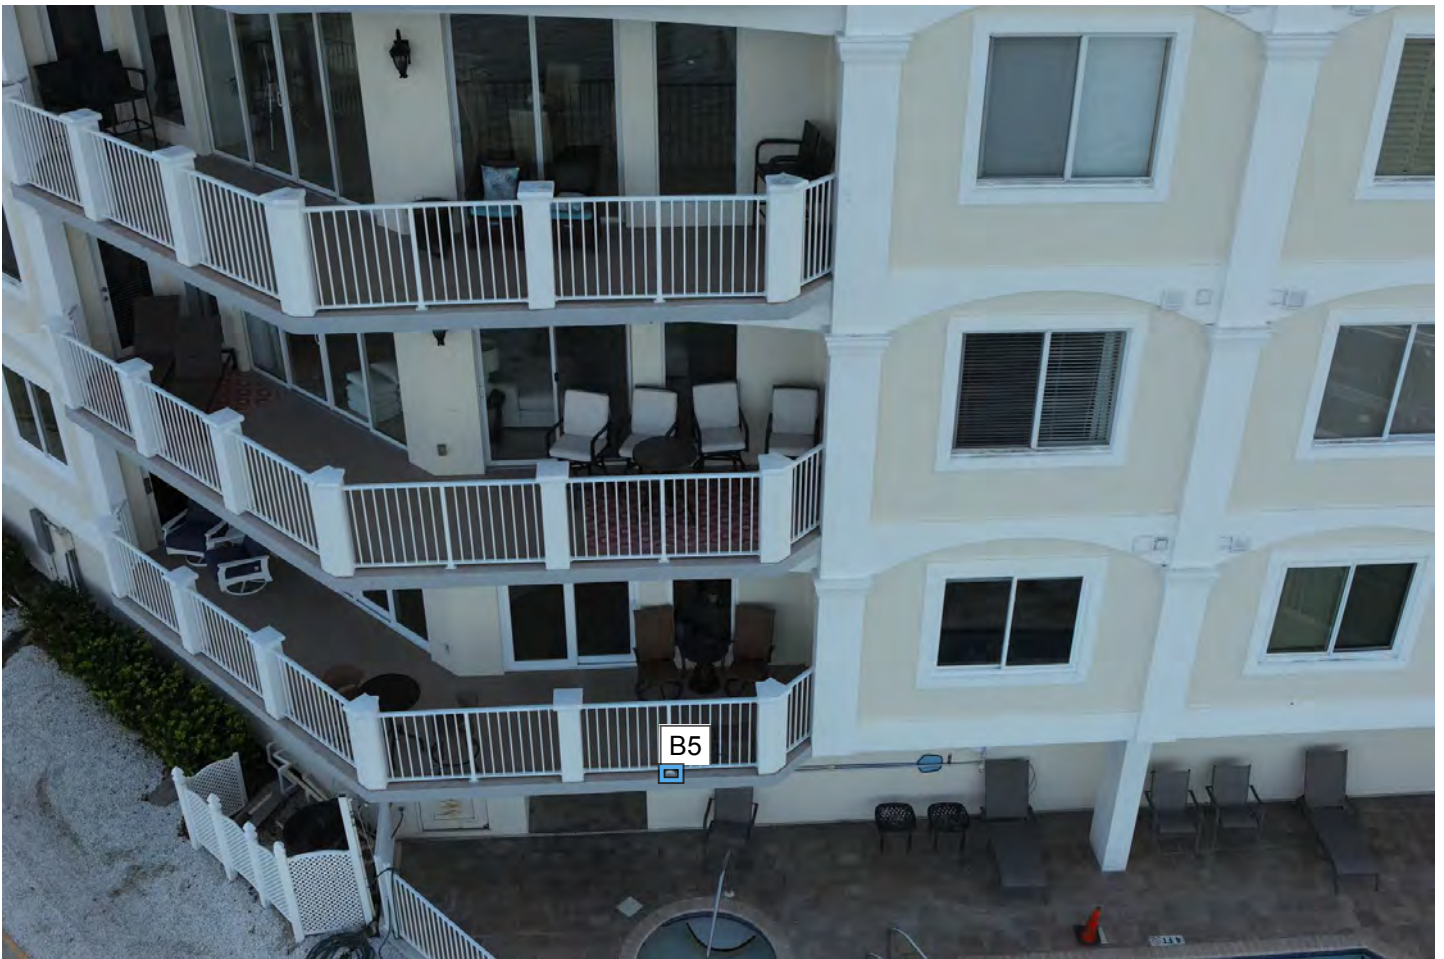
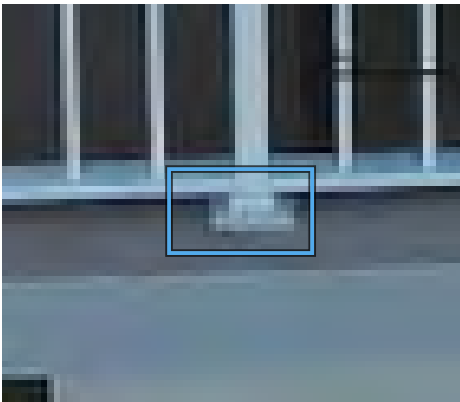
B5

Title: Water Pooling

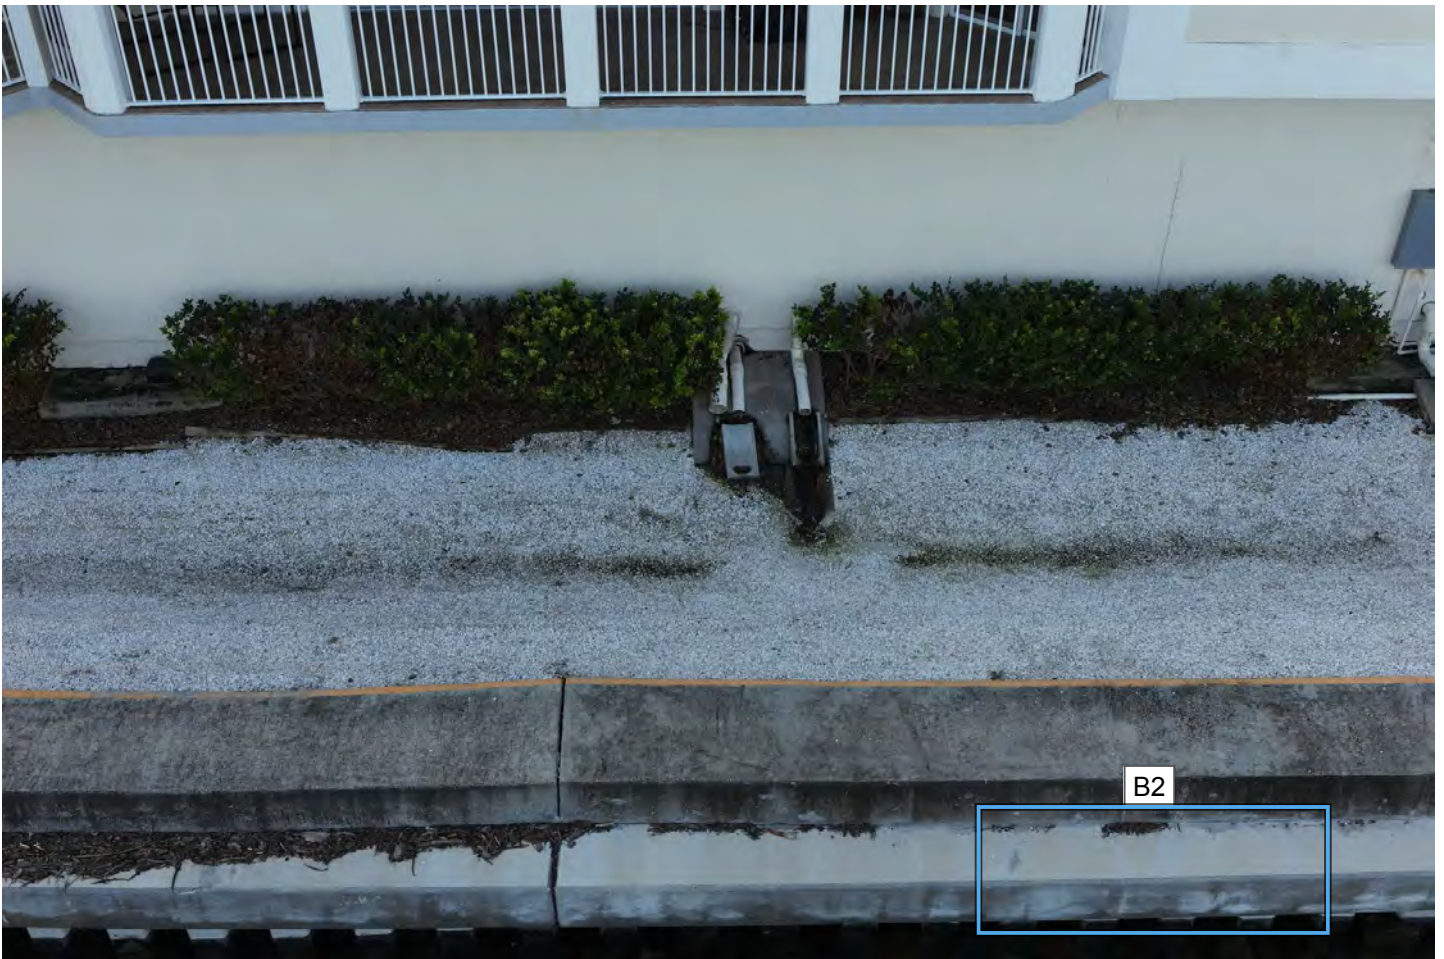
B2

Title: Separation

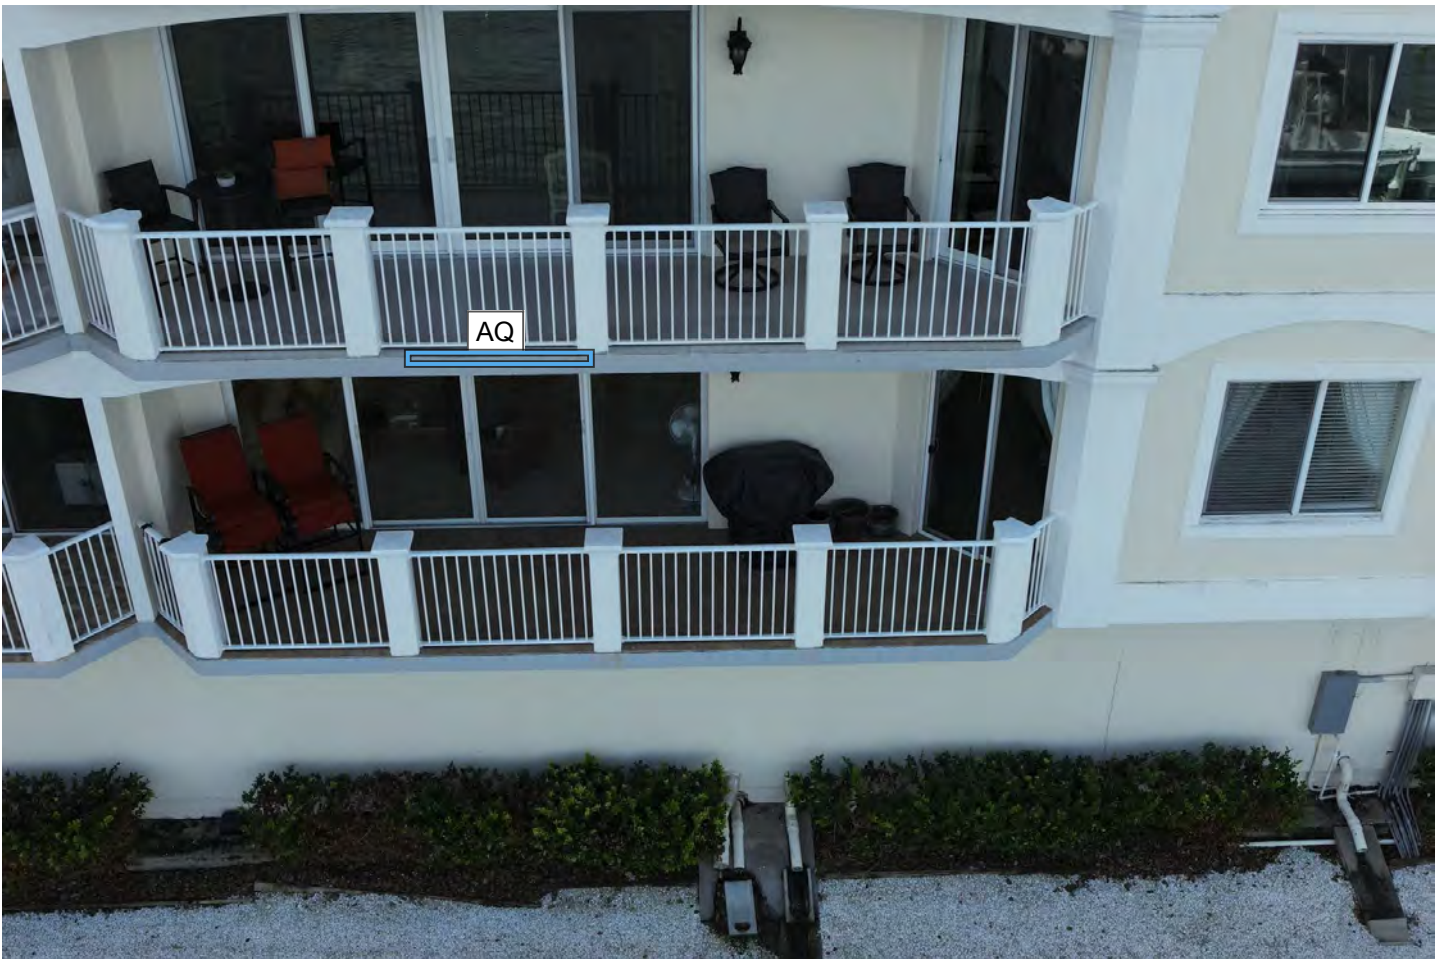
AQ

Title: Cracks

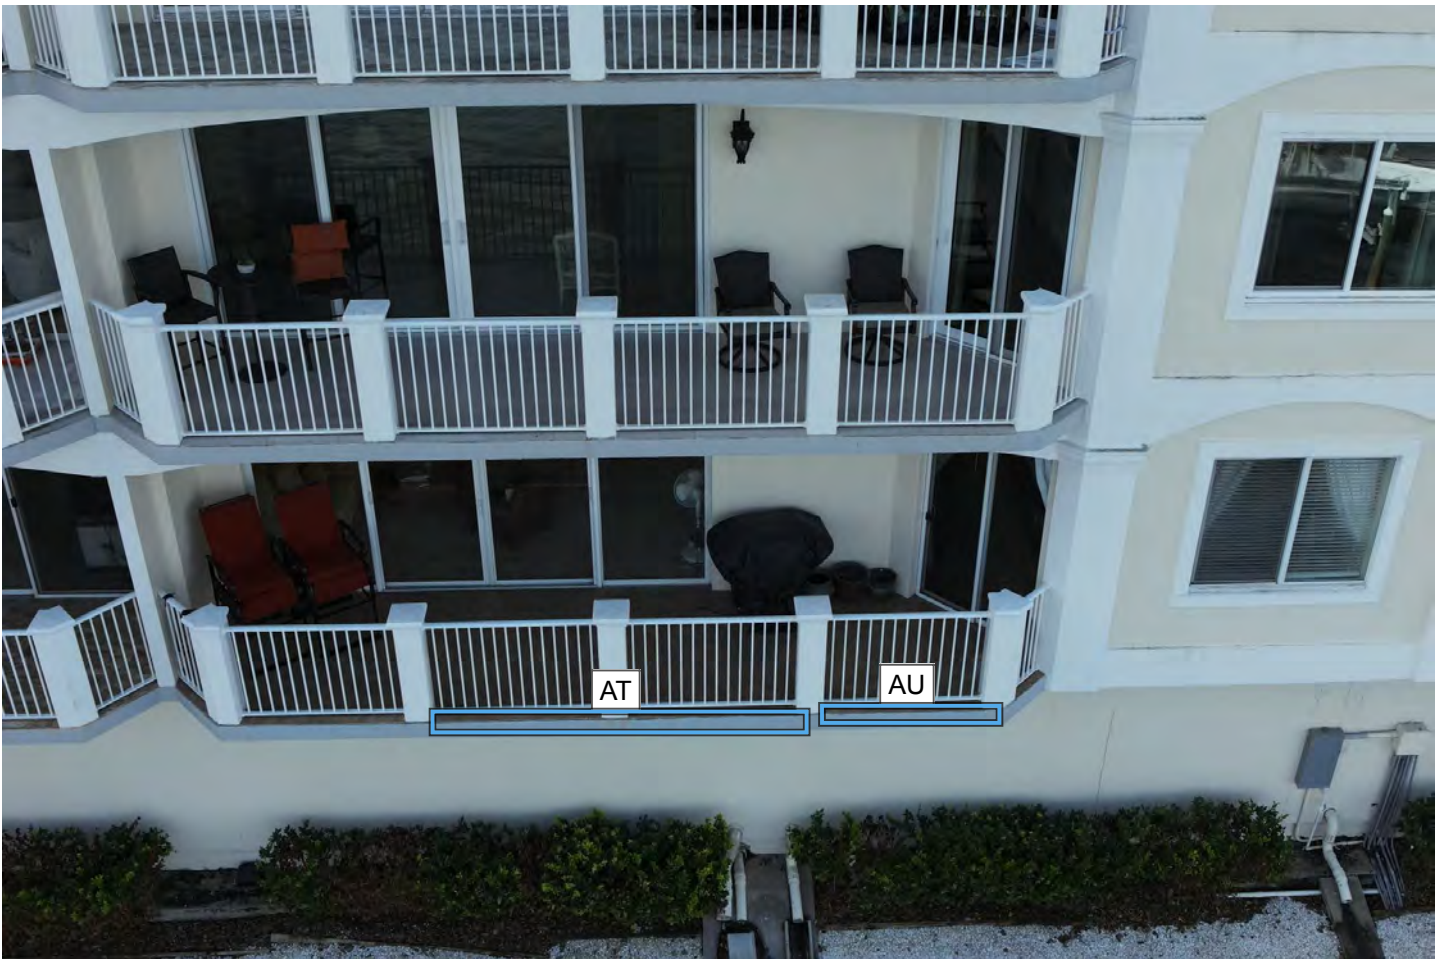
AT

Title: Separation

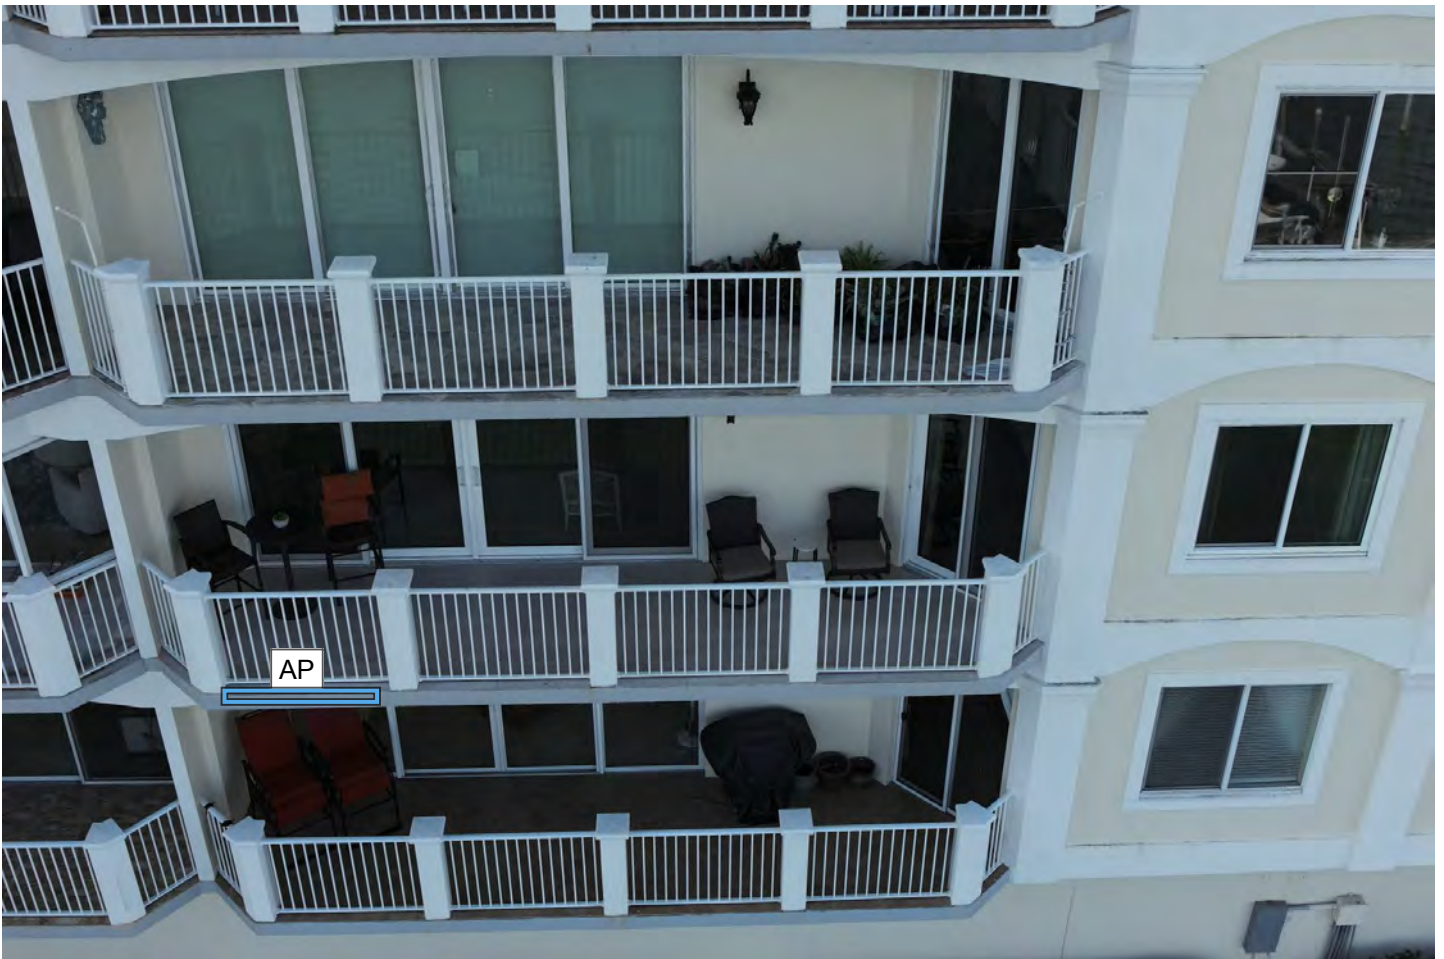
AP

Title: Separation

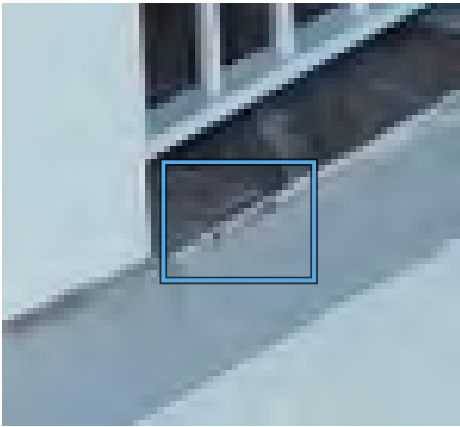
AI

Title: Separation

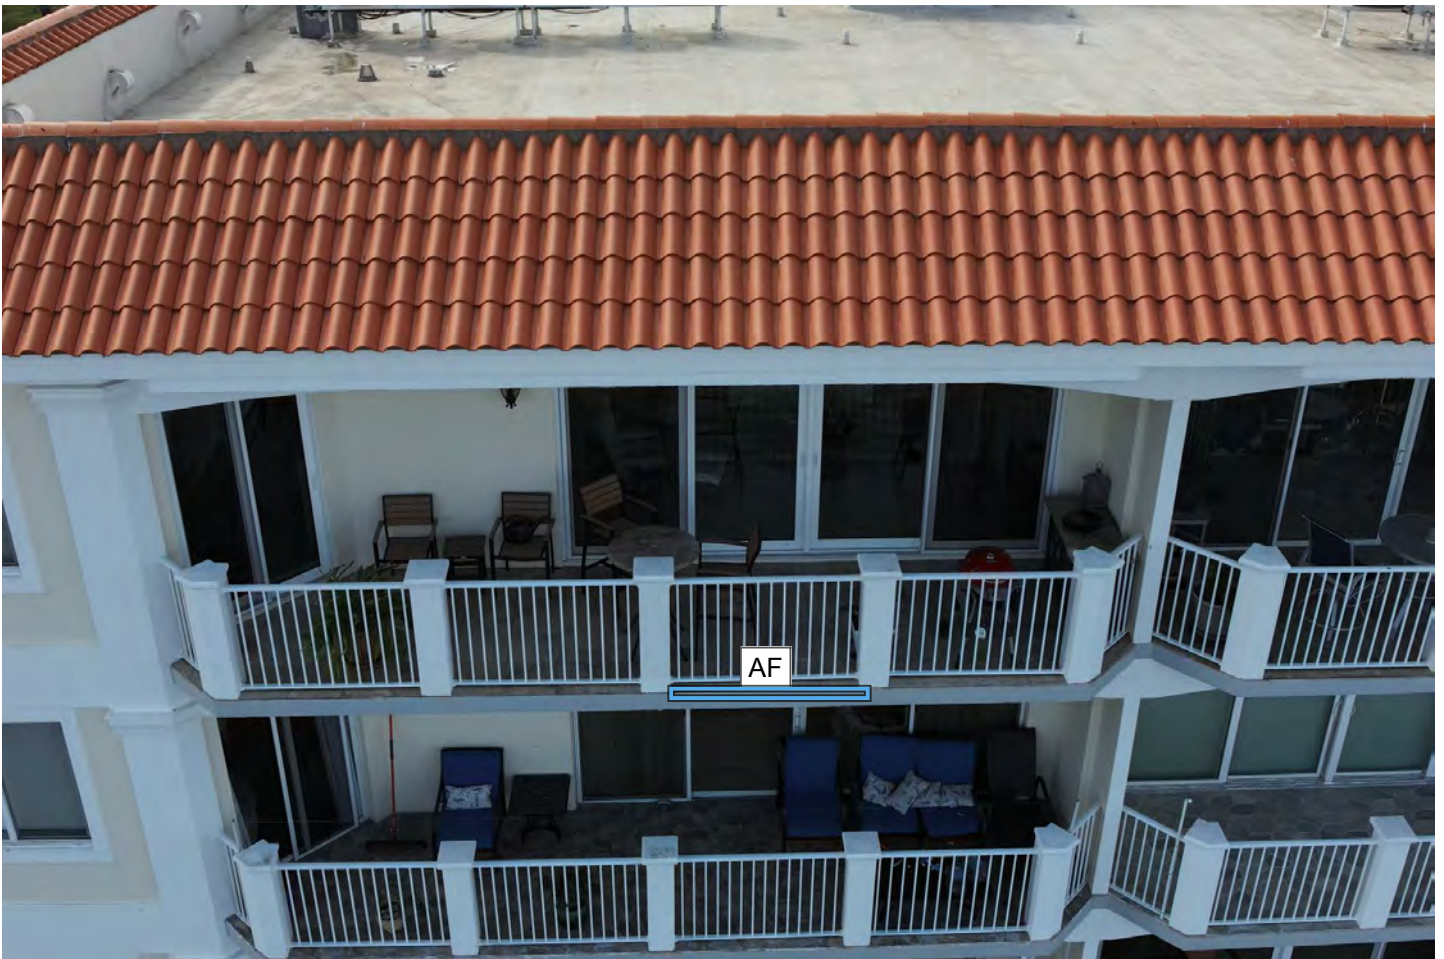
AF

Title: Separation

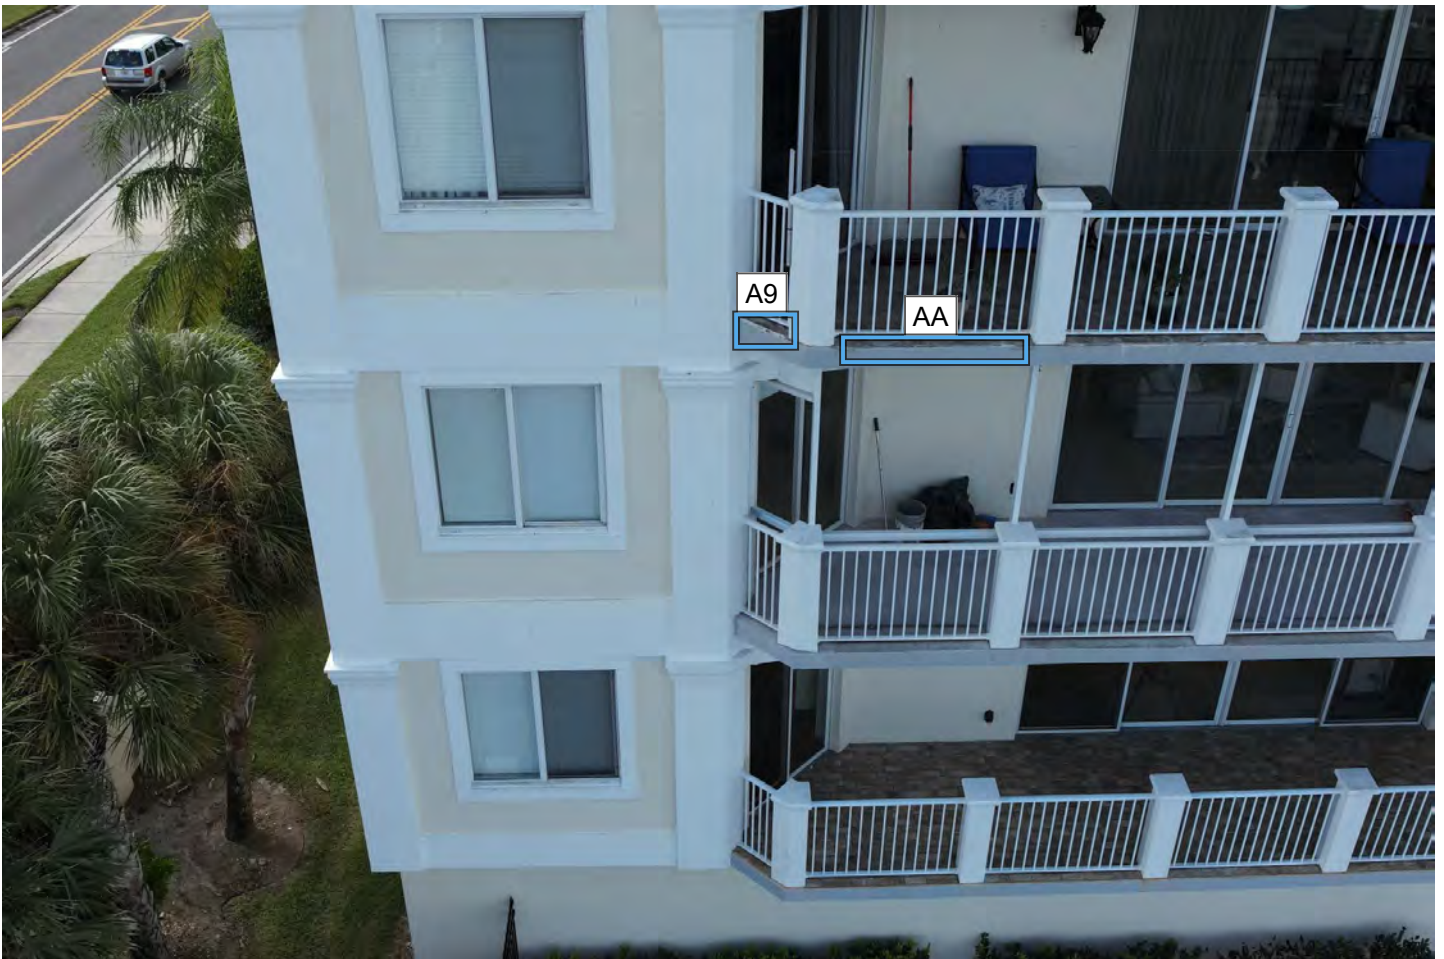
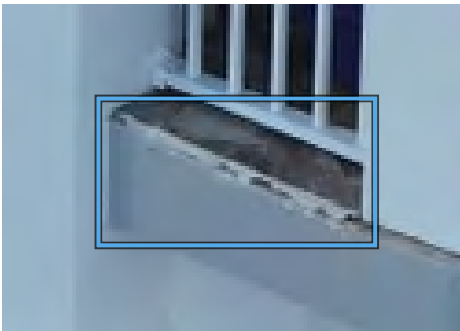
A9

Title: Separation

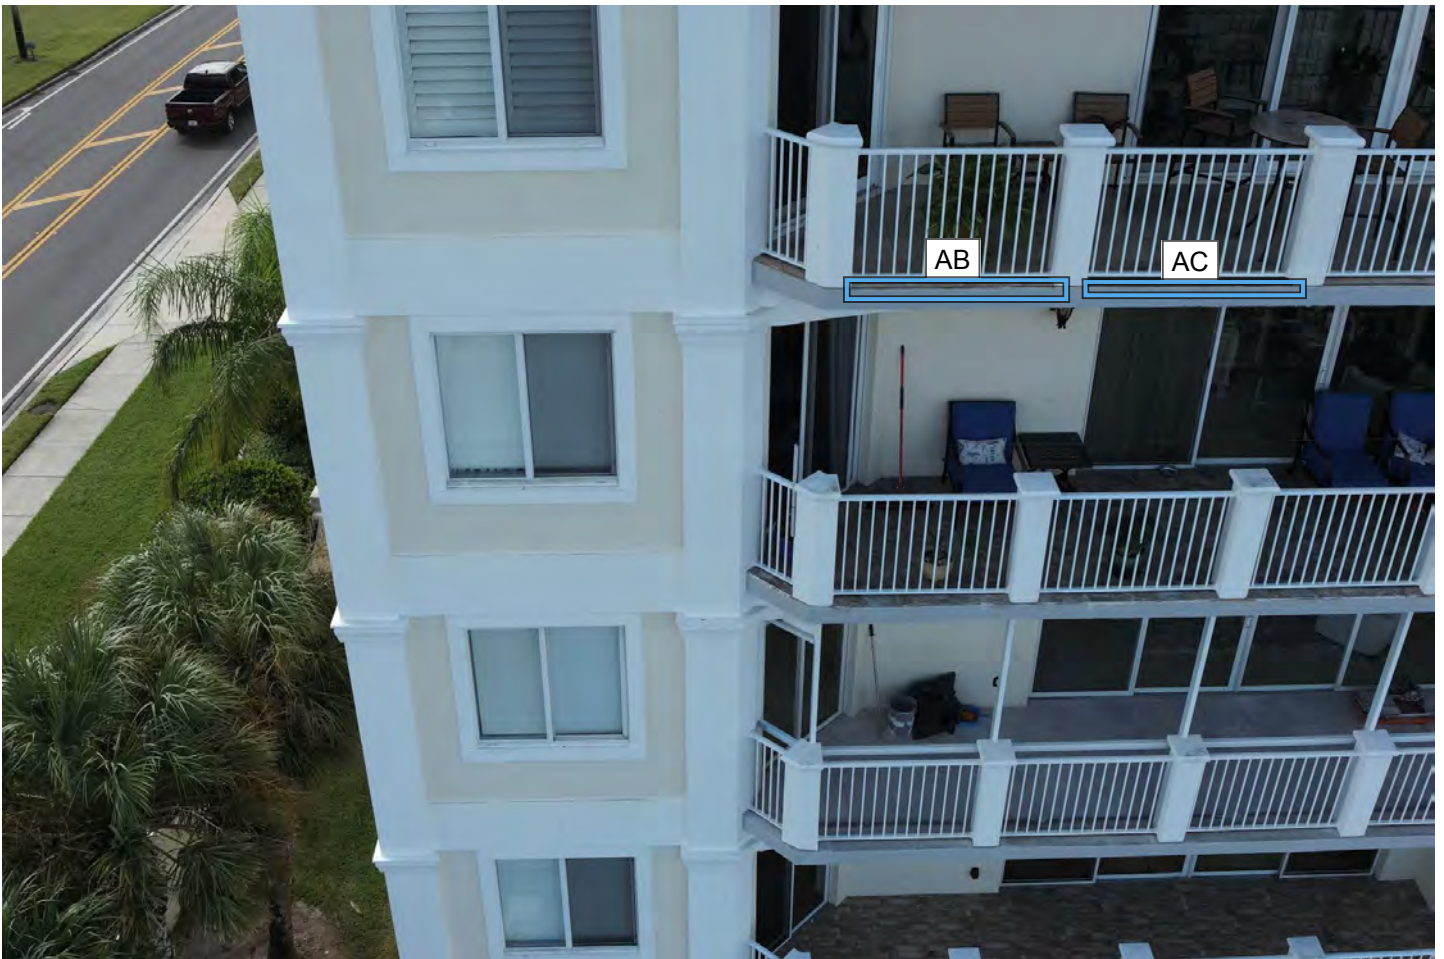
AB

Title: Separation
