Reserve Study

Villa Del Mar of Clearwater COA

1860 N Fort Harrison Ave, Clearwater, Florida 33755

February 2, 2024

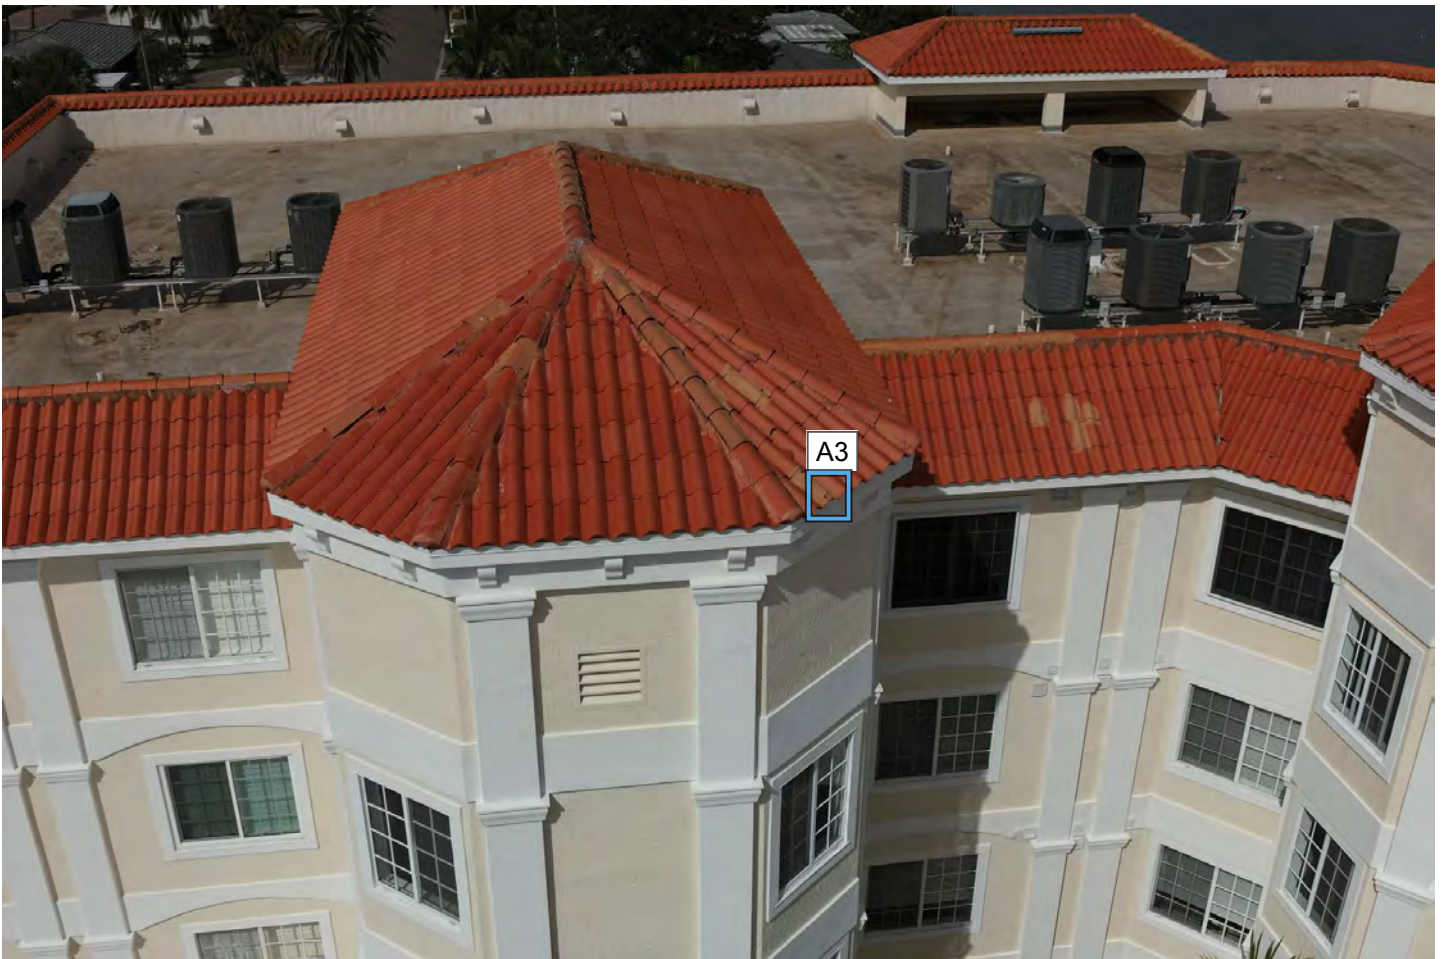
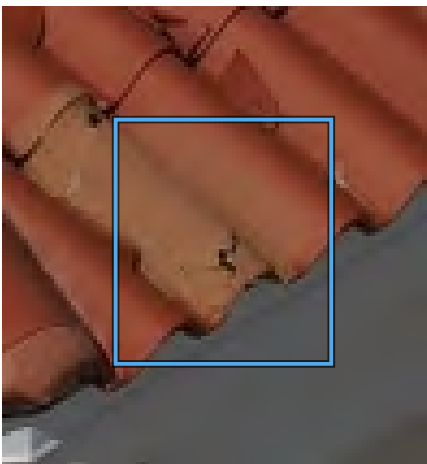
A3

Title: Chipped Tile

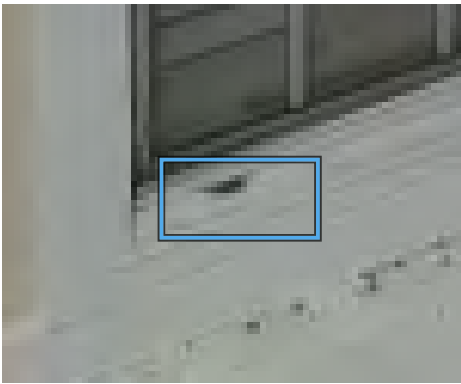
A2

Title: Water Pooling
